NASA Technical Memorandum 105234

# The Chemistry of Saudi Arabian Sand: A Deposition Problem on Helicopter Turbine Airfoils

James L. Smialek  
*Lewis Research Center*  
*Cleveland, Ohio*

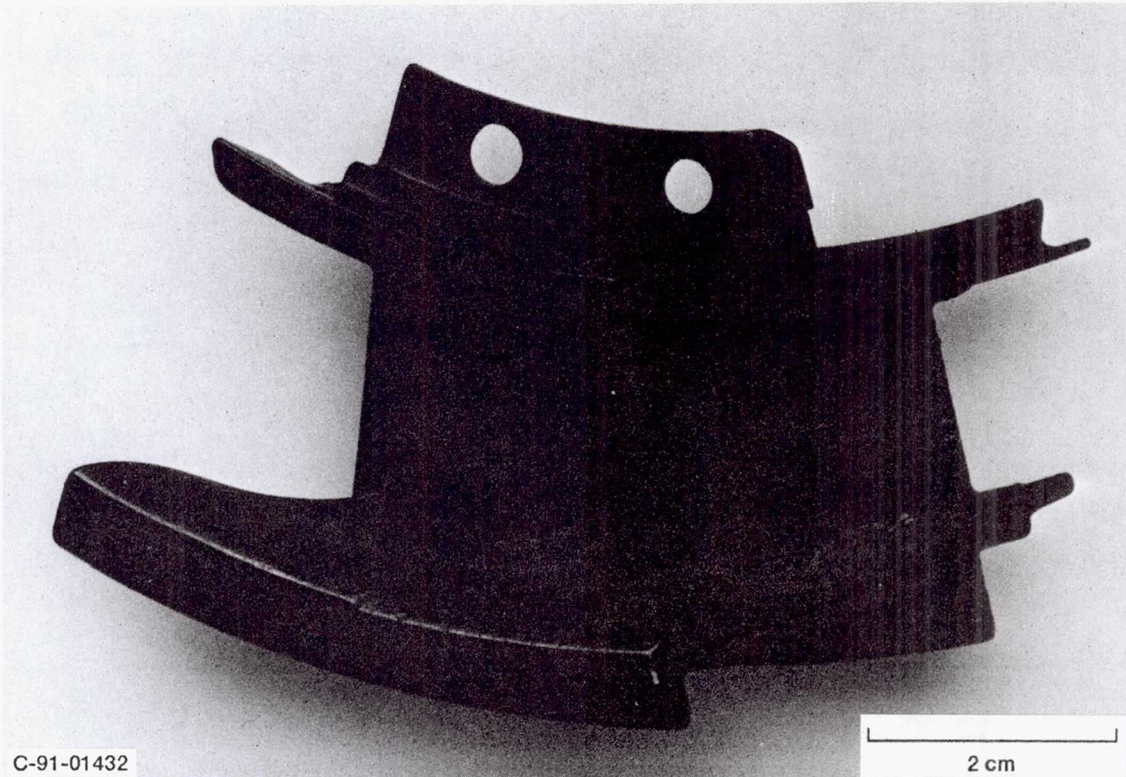
By December 1990, turbine performance losses were reported for Black Hawk personnel transport helicopters operating in the Persian Gulf. Engine teardown and rehab tests verified that sand erosion of compressor airfoils accounted for most of the loss. At this time, unusual amorphous deposits were observed on the leading edges of the first stage turbine vanes. An example of a clean vane (aluminized X-40) is shown in figure 1. While there was no indication of hot corrosion and the deposits were easily removed in a cleaning procedure, they were also quite thick (up to 0.25 in.) and covered a portion of the airfoil (up to 0.5 in. long). An example of such a deposit is shown in figure 2. There was concern over the exact nature of these deposits and the potential for future corrosion problems. The cooling passages in these engines also contained a talc-like brown powder whose corrosive properties were also a concern. The connection between ingested sand, vane deposits, and cooling passage powders was the focus of this analytical study.

Figure 1.—First stage vane pair from T-700 turbine engine used in Black Hawk helicopters. (Codep aluminide coated X-40 cobalt alloy).

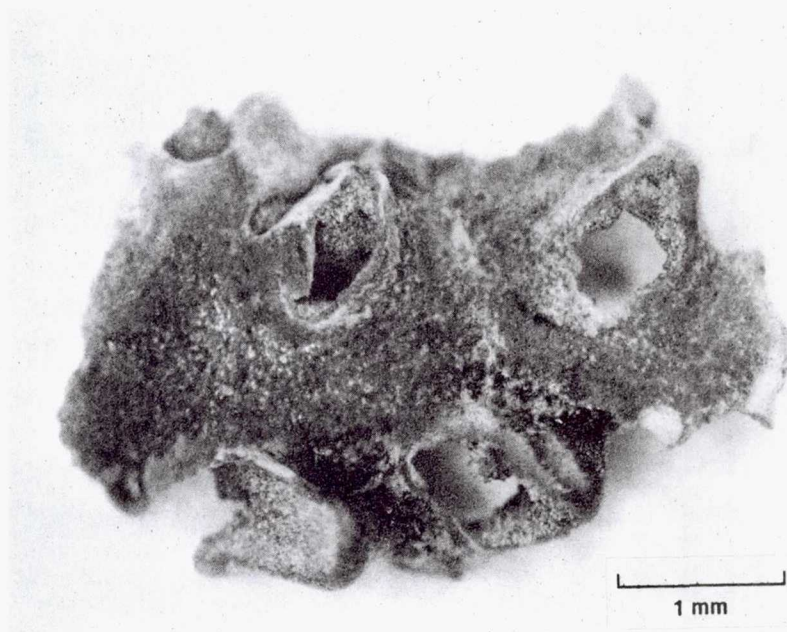
Deposit morphology. - The deposits formed at the base of the vane leading edges. In some vanes the cooling air prevented hole-plugging (fig. 2), while others were completely covered over. There was evidence of some viscous glassy flow (fig. 5). The metallographic cross-section shown in figure 6 exhibits a featureless glassy matrix (grey), numerous large pores (black), and some second phase precipitates (lighter grey). Some bright metallic particles were also present as unreacted erosion products.

Figure 2.—Macrograph of leading edge vane deposit showing openings at cooling hole locations.

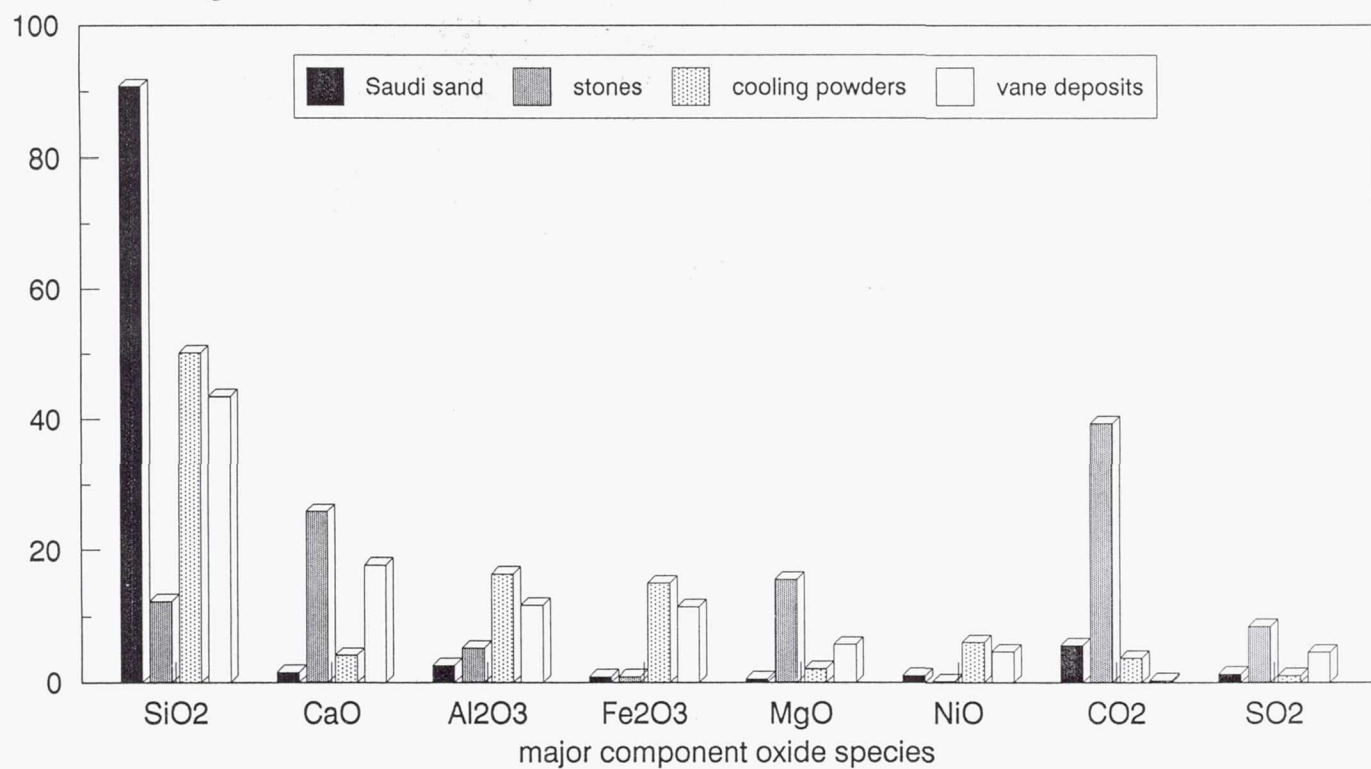
Composition. - The chemical analyses shown in table I are the averages of similar sand, powder, and deposit samples. The elemental compositions (including C and S) have been converted to their corresponding oxides and normalized to 100 percent by weight. This facilitates direct comparison to complex silicate, carbonate, and sulfate compositions in the literature. However, the exact phases present can only be determined by the XRD results. The data is displayed graphically for the major and minor elements in figures 3 and 4.

The dune and river bed samples were primarily  $\text{SiO}_2$ , with minor amounts of  $\text{Al}_2\text{O}_3$ ,  $\text{CaO}$ ,  $\text{NiO}$ ,  $\text{Fe}_2\text{O}_3$ ,  $\text{MgO}$ , and  $\text{K}_2\text{O}$ . Carbon and sulfur were present as carbonates and sulfates. X-ray diffraction identified low quartz as the primary phase, while some larger particles contained  $\text{CaCO}_3$  calcite.

The cooling passage powders were high in silica but not as high as the as-received sand. They were comparatively high in  $\text{Al}_2\text{O}_3$  and  $\text{Fe}_2\text{O}_3$ , with increases in minor elements, such as  $\text{NiO}$ ,  $\text{TiO}_2$ , and  $\text{Cr}_2\text{O}_3$ . X-ray diffraction identified only quartz and possibly  $\text{CaSO}_4$ . Erosion of stainless steel and Ti-6Al-4V compressor hardware accounts for additional metals in the powders. The high  $\text{Al}_2\text{O}_3$  content of these powders can be accounted for by the high  $\text{Al}_2\text{O}_3$  content of the fines in the sand, 14 percent  $\text{Al}_2\text{O}_3$  for -20  $\mu\text{m}$  particles (not shown in table I) versus 2.5 percent  $\text{Al}_2\text{O}_3$  overall. Since the powders were less than 10  $\mu\text{m}$ , they more closely represent the composition of the fine sand actually entering the turbine.

The resultant deposits were related to the chemical factors above. The levels of  $\text{SiO}_2$ ,  $\text{Al}_2\text{O}_3$ ,  $\text{Fe}_2\text{O}_3$ , and minor compressor alloying elements were similar to those of the powders. However,  $\text{CaO}$  and S increased, consistent with the  $\text{CaSO}_4$  found on the inner surface of the deposit by X-ray diffraction, while carbon decreased.  $\text{CaO}\cdot\text{MgO}\cdot 2\text{SiO}_2$  diopside was the major crystalline phase, while quartz was a very weak phase.

Figure 3.—Analyzed composition of Saudi Arabian sand and helicopter engine deposits. (Presented as oxide species normalized to 100% total. Averages of 3 sand and one river bed stone sample; averages of cooling passage powders and vane deposits from 4 engines). Major components.

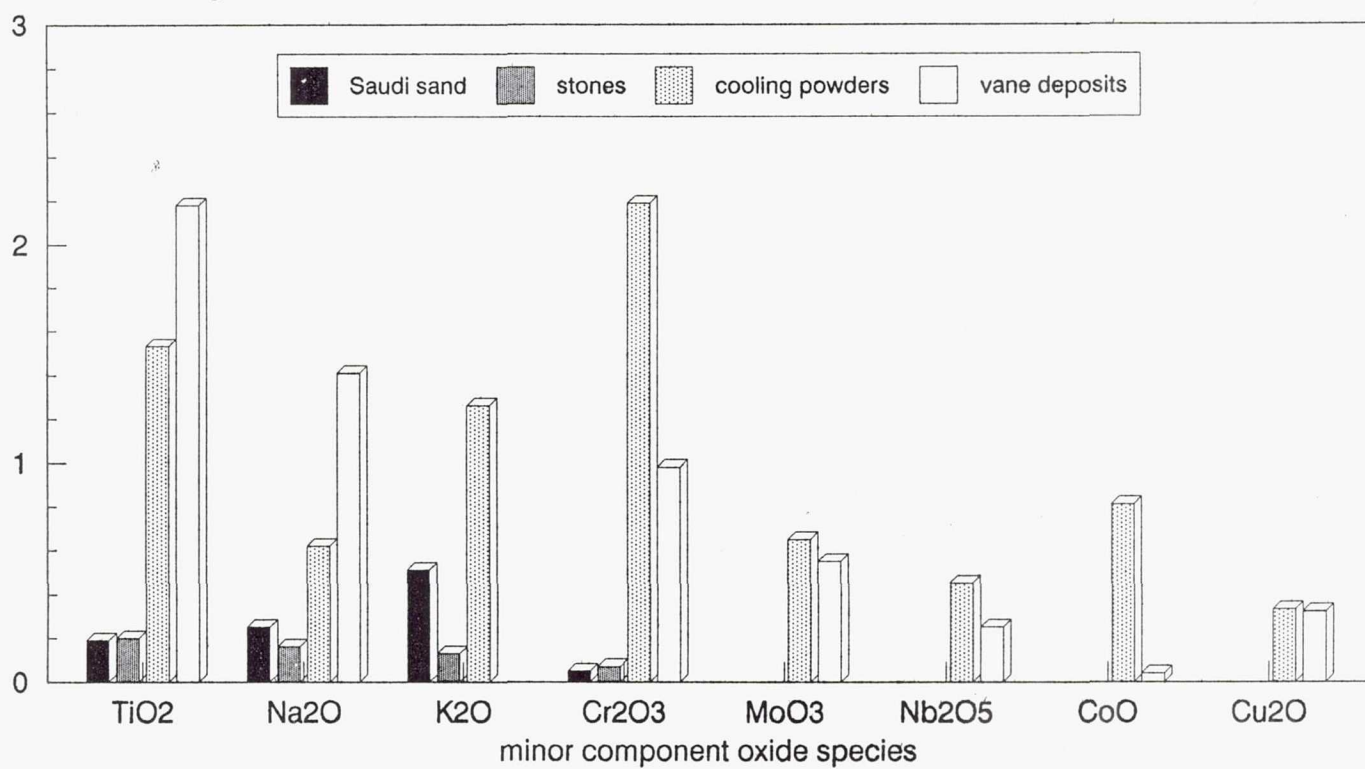
Figure 4.—Analyzed composition of Saudi Arabian sand and helicopter engine deposits. (Same considerations as figure 3).  
Minor components.

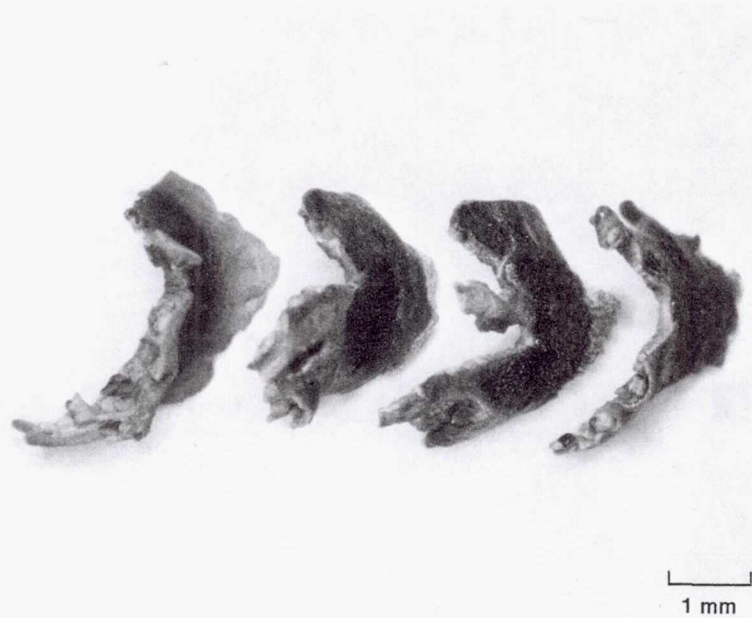
Molten glassy phases were thus likely only during the impaction process and would account for some viscous flow and the glassy appearance of the deposit. Since the melting point exceeds normal vane temperatures by more than 200 °C, the glass and the potentially corrosive  $\text{CaSO}_4$  phase are not expected to be totally molten for any period of time. This is consistent with the absence of severe corrosion effects.

Figure 5.—Macrograph of four leading edge vane deposits showing viscous flow patterns around sides.

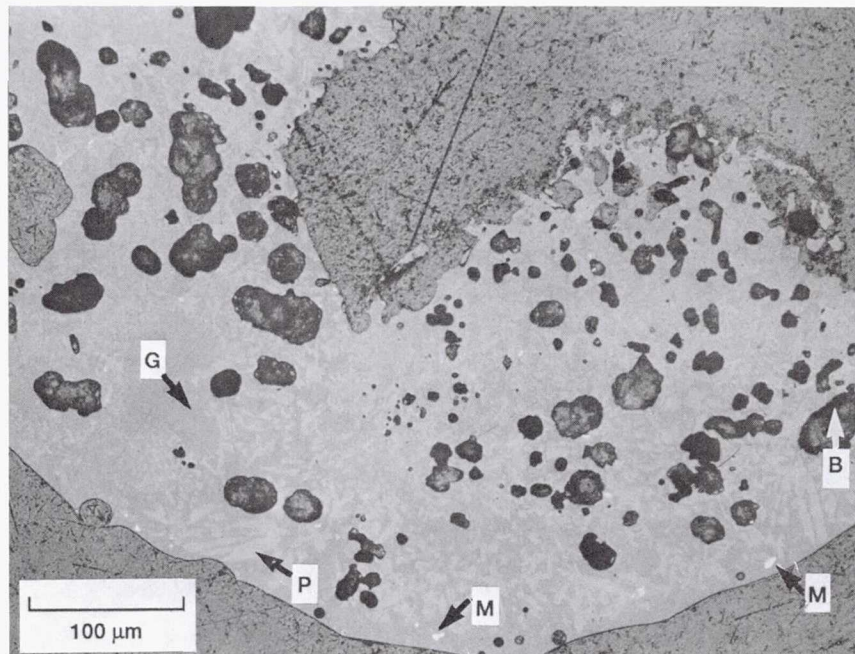
The porosity in the deposit can be rationalized by  $\text{CaCO}_3$  decomposition in the deposit, if it is assumed that it first survives the hot gas path.  $\text{CO}_2$  gas bubbles would result with an enrichment in the CaO content of the glass. This trend is consistent with the decreased C and increased Ca contents of the deposits compared to the powders (table I).

Figure 6.—Optical micrograph of vane deposit. Polished cross-section showing glassy Ca-Al-Fe silicate matrix with CaO-MgO-2SiO<sub>2</sub> diopside precipitates from impacted sand, Fe-Ti metallic inclusions from compressor erosion, and gas bubbles from CaCO<sub>3</sub> decomposition. (G = glass, P = diopside precipitates, M = metallic inclusions, B = gas bubbles).

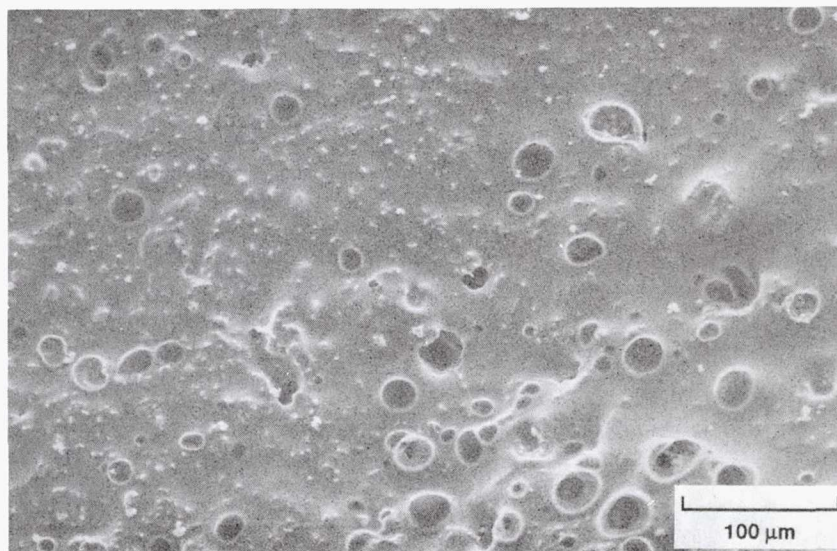
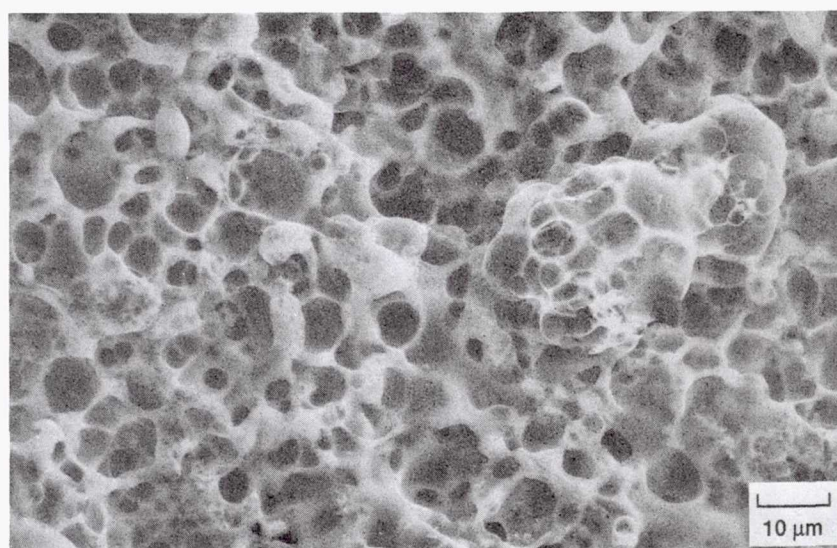
An SEM micrograph of the exterior surface (fig. 7) again reveals a smooth glassy surface with porosity. EDS analysis showed (in descending order) high intensity peaks of Si, Ca, and Al, intermediate levels for Fe (and S on the inner surface only), and low levels for Mg, Ti, Cr, K, and Na. This is very consistent with all the chemical analysis results on the deposits. The inner surface sulfur peak agrees with the  $\text{CaSO}_4$  found on this surface by XRD.

Figure 7.—SEM micrographs of glassy external deposit surface with gas bubbles.
